**The Corporation of the Municipality of Wawa
Report**

Prepared For: Planning Committee	Report No.: CAO-2017-05
Agenda Date: March 28, 2016	Report Date: March 13, 2017

The subject of this report relates to the consideration of a Community Hub for the purposes of a combined public services building including; municipal office, OPP, courthouse and fire department.

PRELIMINARY FEASIBILITY: COMMUNITY HUB

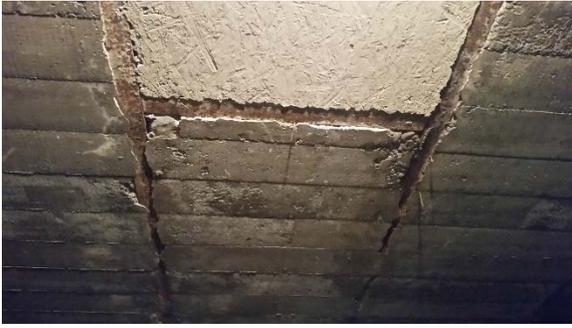
Photograph 1 ↑
Looking at concrete ceiling (and patch) located in former file storage room, in basement, where historic water intrusion events have occurred from.

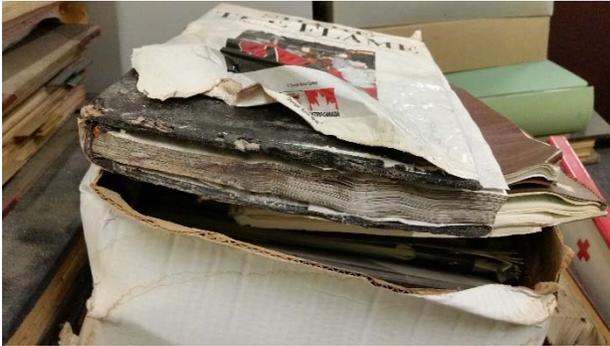
Photograph 3 ↑
Looking water damaged and mould growth on surface of file document binders

Based on the observed area of mould growth Pario would recommend that the remediation of mould contaminated building materials and contents, along with a general cleaning of the entire Site should generally follow "Level II Mould Abatement" in accordance with the Canadian Construction Association standard CCA 82 *"Mould guidelines for the Canadian Construction Industry – February 2004"*. Additionally, due to the historic moisture-related issues associated with the basement level, and further to our assessment, Pario recommends that intrusive investigations of the exterior weeping tile systems and drainage be completed to identify potential sources of water retention against the basement foundation walls. The presence of efflorescence on the concrete wall finishes indicates the presence of a hydrostatic pressure (water accumulation) in the areas along the exterior of these foundation walls. This moisture source is expected to have raised the basement's relative humidity and is considered a contributing factor in the mould presence identified. Intrusive excavations may be needed along the exterior in these areas to check the condition of damp proofing equipment installed along the foundation walls of concern. It is strongly recommended that any moisture sources be addressed prior to any abatement work being conducted.

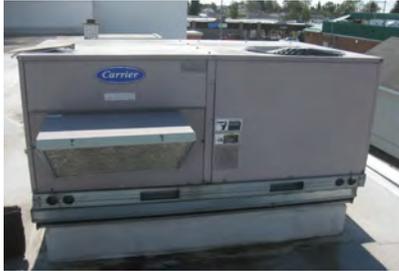
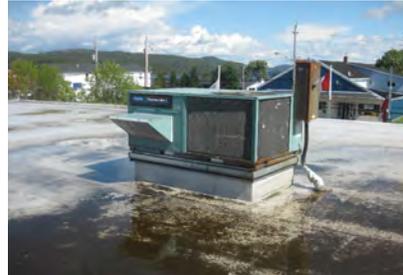
- 3) The Main administrative area of the Municipal building is conditioned by an aged 5 Ton combination electric heat / electric cool heat pump rooftop unit. We were not able to confirm the year that this unit was manufactured, but the serial number seems to indicate that it may have been built in 1989, suggesting that it over 26 years old. Remarkably this existing old rooftop unit has remained in service well beyond its typical life expectancy. The unit is a Carrier Weathermaker I #50QJ006-300 series, c/w auxiliary

electric ductheater and free-cooling economizer provisions. In 1995, new state-of-the-art computerized Carrier VVT BMS Controls were added onto this existing HVAC system, in order to provide better comfort and control to the various areas that it serves. It appears that approximately c/w six VVT zone control dampers and a dual Bypass control damper arrangement were incorporated onto this existing HVAC system. These zone control dampers are capable of providing variable volume & temperature for each zone, and appear to have supplemental relays interconnected to electric heating. We were unable to confirm if these aux. relays are still functional.

It should be noted that there was quite a bit of standing water noted on the roof around this older HVAC unit. Supplemental roof drainage could be installed to help alleviate this problem, and avoid potential roof leaks.

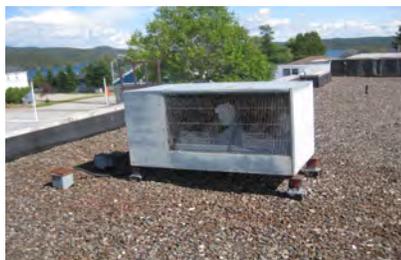
3) The remainder of the Municipal Building, including the Police Department (basement & lower Ground Floor areas), as well as the upper Council Chamber / Court Room areas, are still be conditioned by an interior heat pump system (AHU#1), with the Fan Coil located in the Basement Mechanical Room, and a remote exterior A/C condenser mounted on the roof. This original HVAC system has a main 22.5 KW-208V-3Ph electric ductheater, and also has a series of electric reheat coils incorporated to service the various areas. Not surprisingly, the original Lennox fan coil blower section appears to have been replaced in recent years (not able to confirm date of manufacture), and is now a Lennox #B3-95-2 series heat pump fan coil. This fan coil appeared to be in moderately good shape and operational. However the electric reheat coils and the 38 year old roof mounted exterior condenser still appear to be the original 1977 vintage. Remarkably this condenser unit is still operational, however it appears that it has had many parts (i.e. Compressor) replaced over the years to keep it operational. The existing A/C refrigerant is R22 which is no longer manufactured, and is currently being phased out.

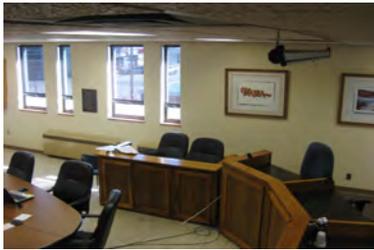
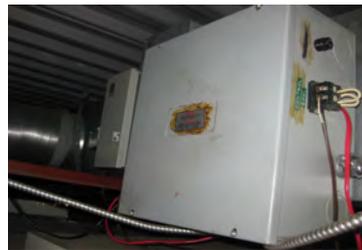
4) It appears that the original 1977 HVAC design of this interior AHU#1 system, was not designed to be interlocked with the existing electric baseboard heaters located on the perimeter of the building, and it was noted that these perimeter electric heaters were actually ON at the time of this inspection, even though the AHU#1 unit was in cooling mode. Obviously, this is a case of heating fighting cooling, and a waste of energy. Existing electrical panel 'C' seem to have quite a few circuit breakers dedicated to electrical baseboard heating.

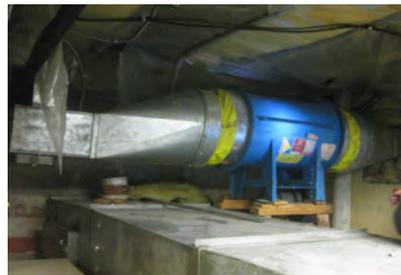
5) The building washrooms and holding cells located on both floors, on the south end of the building, are serviced by an existing large inline exhaust fan (Air-Care #129-Tubular) that is located in the Basement Mechanical Room. This exhaust fan itself is from original construction (1978), but it appears the fan motor has been replaced in recent years. This exhaust system appeared to be functional, however with the continuous discharge of exhaust air to the outside, forces the AHU#1 unit to continually bring in fresh air (MUA) to compensate for the pressure differential being created by the exhaust fan. The introduction of fresh air is desired, but there are much better and more energy efficient means to accomplish these provisions. When there is a negative pressure differential in the building, this creates drafts and envelope leakage, as make-up air (MUA) will try to infiltrate into the building through cracks around windows, doors, etc. This can cause comfort issues, and is not energy efficient. Typical office building design would be just the opposite, whereby the building actually has a slight positive pressurization to keep cold (or warm) outside air from infiltrating the building.

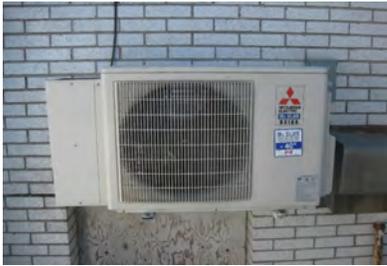
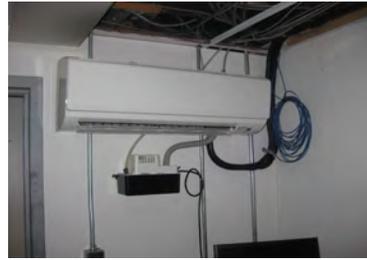
8) The Office building computer LAN room located in the basement is conditioned by a newer 1 Ton Ductless Split A/C system c/w -40F ultra-low ambient controls & crankcase heater. (Mitsubishi #PUY-A12NHA3 series c/w interior Fan coil and an exterior condenser unit). The serial number on the unit appears to indicate that it was manufactured in 2005, making it a 10 year old system. Typically these units have a 20 year life expectancy, considering that they work all year round. This system appeared to be in good operational condition.
