**The Corporation of the Municipality of Wawa  
Report**

| <b>Prepared For: Planning Committee</b> | <b>Report No.: CAO-2017-05</b> |

The subject of this report relates to the consideration of a Community Hub for the purposes of a combined public services building including; municipal office, OPP, courthouse and fire department.

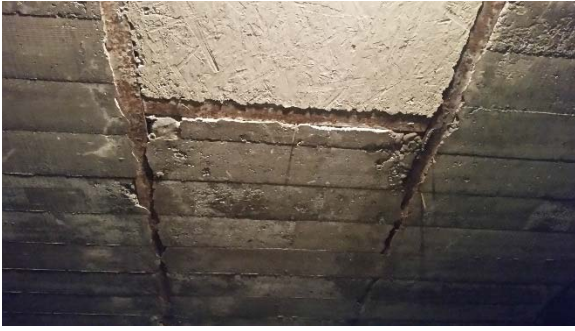
**Photograph 1 ↑**  
Looking at concrete ceiling (and patch) located in former file storage room, in basement, where historic water intrusion events have occurred from.

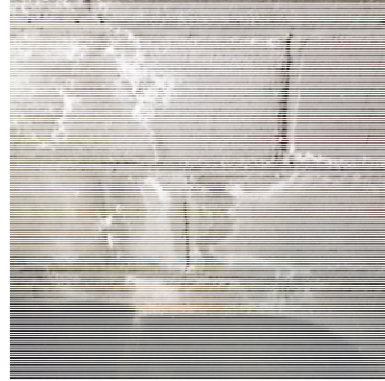
**Photograph 2 ↑**  
Looking at concrete block wall located in the former file storage room, in basement, where mould growth concerns existed (sample MW-B1).

Furthermore, the presence of efflorescence indicates a hydrostatic force pushing the calcium out of the concrete so there might be a foundation leakage, drainage, or damp proofing issue, which should be further investigated and addressed.

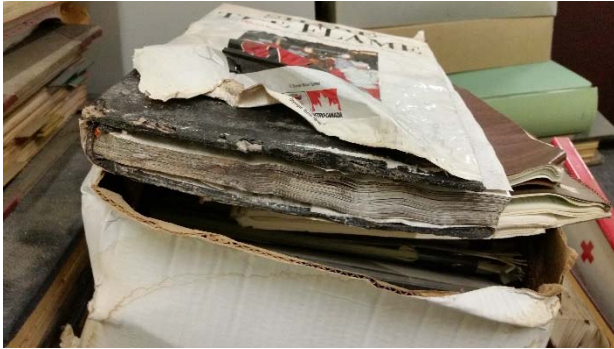
**Photograph 3 ↑**  
Looking water damaged and mould growth on surface of file document binders

Based on the observed area of mould growth Pario would recommend that the remediation of mould contaminated building materials and contents, along with a general cleaning of the entire Site should generally follow "Level II Mould Abatement" in accordance with the Canadian Construction Association standard CCA 82 *"Mould guidelines for the Canadian Construction Industry – February 2004"*. Additionally, due to the historic moisture-related issues associated with the basement level, and further to our assessment, Pario recommends that intrusive investigations of the exterior weeping tile systems and drainage be completed to identify potential sources of water retention against the basement foundation walls. The presence of efflorescence on the concrete wall finishes indicates the presence of a hydrostatic pressure (water accumulation) in the areas along the exterior of these foundation walls. This moisture source is expected to have raised the basement's relative humidity and is considered a contributing factor in the mould presence identified. Intrusive excavations may be needed along the exterior in these areas to check the condition of damp proofing equipment installed along the foundation walls of concern. It is strongly recommended that any moisture sources be addressed prior to any abatement work being conducted.

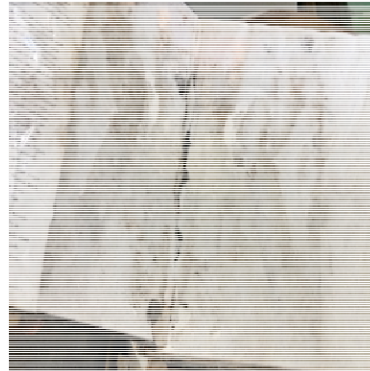
**Photograph 4 ↑**  
Looking at mould growth on the surface of paper files, located in document binders.

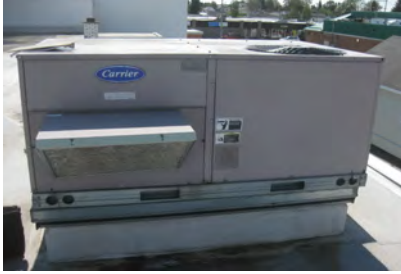
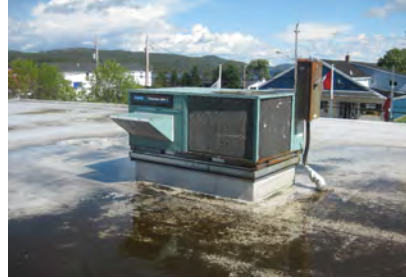
3) The Main administrative area of the Municipal building is conditioned by an aged 5 Ton combination electric heat / electric cool heat pump rooftop unit. We were not able to confirm the year that this unit was manufactured, but the serial number seems to indicate that it may have been built in 1989, suggesting that it over 26 years old. Remarkably this existing old rooftop unit has remained in service well beyond its typical life expectancy. The unit is a Carrier Weathermaker I #50QJ006-300 series, c/w auxiliary

electric ductheater and free-cooling economizer provisions. In 1995, new state-of-the-art computerized Carrier VVT BMS Controls were added onto this existing HVAC system, in order to provide better comfort and control to the various areas that it serves. It appears that approximately c/w six VVT zone control dampers and a dual Bypass control damper arrangement were incorporated onto this existing HVAC system. These zone control dampers are capable of providing variable volume & temperature for each zone, and appear to have supplemental relays interconnected to electric heating. We were unable to confirm if these aux. relays are still functional.

It should be noted that there was quite a bit of standing water noted on the roof around this older HVAC unit. Supplemental roof drainage could be installed to help alleviate this problem, and avoid potential roof leaks.

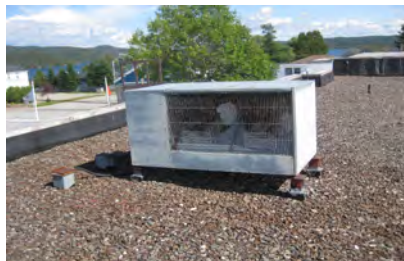
3) The remainder of the Municipal Building, including the Police Department (basement & lower Ground Floor areas), as well as the upper Council Chamber / Court Room areas, are still be conditioned by an interior heat pump system (AHU#1), with the Fan Coil located in the Basement Mechanical Room, and a remote exterior A/C condenser mounted on the roof. This original HVAC system has a main 22.5 KW-208V-3Ph electric ductheater, and also has a series of electric reheat coils incorporated to service the various areas. Not surprisingly, the original Lennox fan coil blower section appears to have been replaced in recent years (not able to confirm date of manufacture), and is now a Lennox #B3-95-2 series heat pump fan coil. This fan coil appeared to be in moderately good shape and operational. However the electric reheat coils and the 38 year old roof mounted exterior condenser still appear to be the original 1977 vintage. Remarkably this condenser unit is still operational, however it appears that it has had many parts (i.e. Compressor) replaced over the years to keep it operational. The existing A/C refrigerant is R22 which is no longer manufactured, and is currently being phased out.

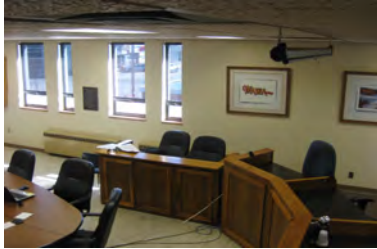
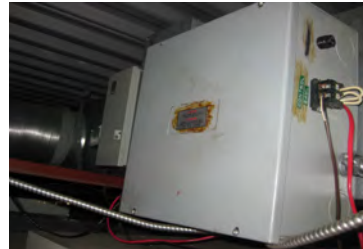
4) It appears that the original 1977 HVAC design of this interior AHU#1 system, was not designed to be interlocked with the existing electric baseboard heaters located on the perimeter of the building, and it was noted that these perimeter electric heaters were actually ON at the time of this inspection, even though the AHU#1 unit was in cooling mode. Obviously, this is a case of heating fighting cooling, and a waste of energy. Existing electrical panel 'C' seem to have quite a few circuit breakers dedicated to electrical baseboard heating.

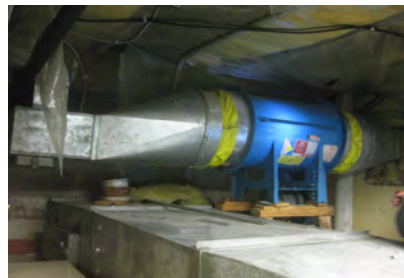
5) The building washrooms and holding cells located on both floors, on the south end of the building, are serviced by an existing large inline exhaust fan (Air-Care #129-Tubular) that is located in the Basement Mechanical Room. This exhaust fan itself is from original construction (1978), but it appears the fan motor has been replaced in recent years. This exhaust system appeared to be functional, however with the continuous discharge of exhaust air to the outside, forces the AHU#1 unit to continually bring in fresh air (MUA) to compensate for the pressure differential being created by the exhaust fan. The introduction of fresh air is desired, but there are much better and more energy efficient means to accomplish these provisions. When there is a negative pressure differential in the building, this creates drafts and envelope leakage, as make-up air (MUA) will try to infiltrate into the building through cracks around windows, doors, etc. This can cause comfort issues, and is not energy efficient. Typical office building design would be just the opposite, whereby the building actually has a slight positive pressurization to keep cold (or warm) outside air from infiltrating the building.

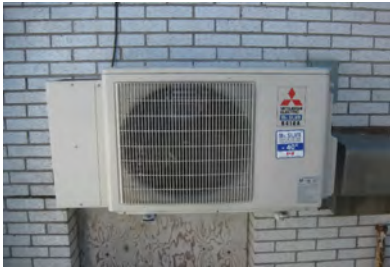
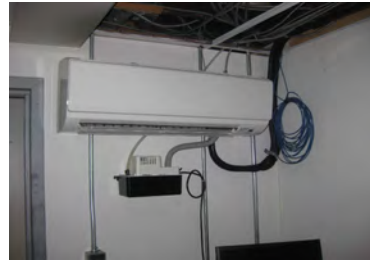
8) The Office building computer LAN room located in the basement is conditioned by a newer 1 Ton Ductless Split A/C system c/w -40F ultra-low ambient controls & crankcase heater. (Mitsubishi #PUY-A12NHA3 series c/w interior Fan coil and an exterior condenser unit). The serial number on the unit appears to indicate that it was manufactured in 2005, making it a 10 year old system. Typically these units have a 20 year life expectancy, considering that they work all year round. This system appeared to be in good operational condition.
