**The Corporation of the Municipality of Wawa
Report**

Prepared For: Planning Committee	Report No.: CAO-2017-09
Agenda Date: November 28, 2017	Report Date: November 18, 2017

The subject of this report is a presentation of the *Business Case* for a Community Hub that would co-locate the Municipal Administration Services, Wawa Public Library, Wawa Fire Department, Provincial Court, the Ontario Provincial Police and Mine Safety Rescue.

PRELIMINARY FEASIBILITY: COMMUNITY HUB

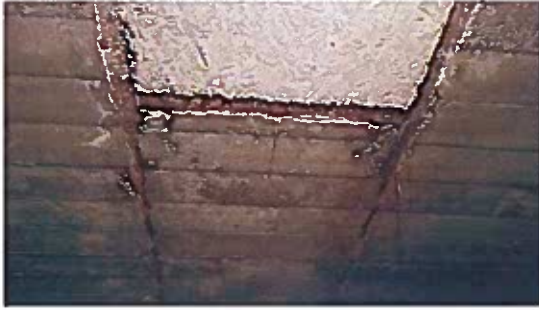
Photograph 1 ↑
Looking at concrete ceiling (and patch) located in former file storage room, in basement, where historic water intrusion events have occurred from.

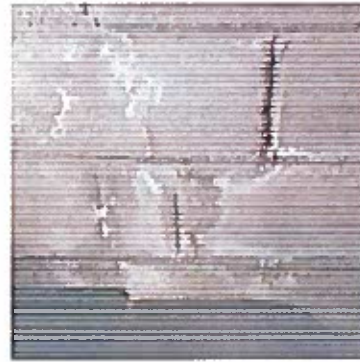
Photograph 2 ↑
Looking at concrete block wall located in the former file storage room, in basement, where mould growth concerns existed (sample MW-B1).

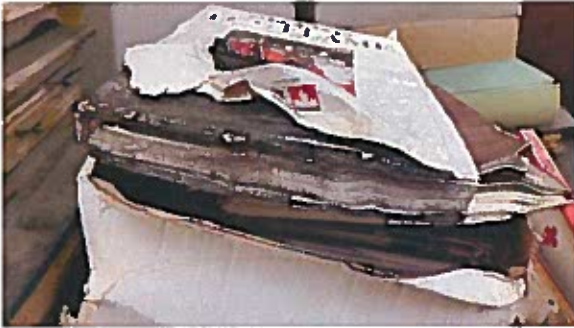
Photograph 3 ↑
Looking water damaged and mould growth on surface of file document binders

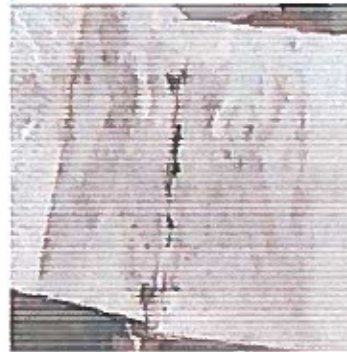
Photograph 4 ↑
Looking at mould growth on the surface of paper files, located in document binders.

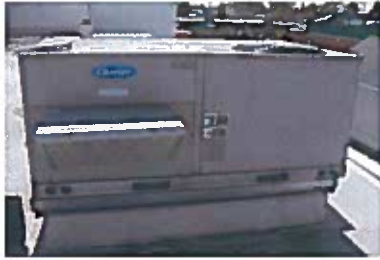
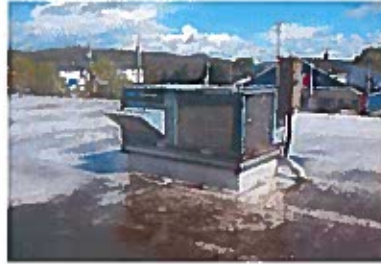
3) The Main administrative area of the Municipal building is conditioned by an aged 5 Ton combination electric heat / electric cool heat pump rooftop unit. We were not able to confirm the year that this unit was manufactured, but the serial number seems to indicate that it may have been built in 1989, suggesting that it over 26 years old. Remarkably this existing old rooftop unit has remained in service well beyond its typical life expectancy. The unit is a Carrier Weathermaker I #50QJ006-300 series, c/w auxiliary

It should be noted that there was quite a bit of standing water noted on the roof around this older HVAC unit. Supplemental roof drainage could be installed to help alleviate this problem, and avoid potential roof leaks.

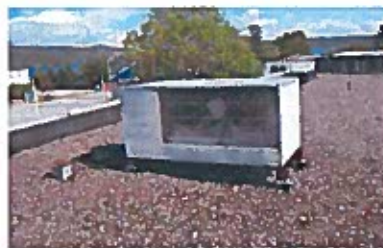
3) The remainder of the Municipal Building, including the Police Department (basement & lower Ground Floor areas), as well as the upper Council Chamber / Court Room areas, are still be conditioned by an interior heat pump system (AHU#1), with the Fan Coil located in the Basement Mechanical Room, and a remote exterior A/C condenser mounted on the roof. This original HVAC system has a main 22.5 KW-208V-3Ph electric ductheater, and also has a series of electric reheat coils incorporated to service the various areas. Not surprisingly, the original Lennox fan coil blower section appears to have been replaced in recent years (not able to confirm date of manufacture), and is now a Lennox #B3-95-2 series heat pump fan coil. This fan coil appeared to be in moderately good shape and operational. However the electric reheat coils and the 38 year old roof mounted exterior condenser still appear to be the original 1977 vintage. Remarkably this condenser unit is still operational, however it appears that it has had many parts (i.e. Compressor) replaced over the years to keep it operational. The existing A/C refrigerant is R22 which is no longer manufactured, and is currently being phased out.

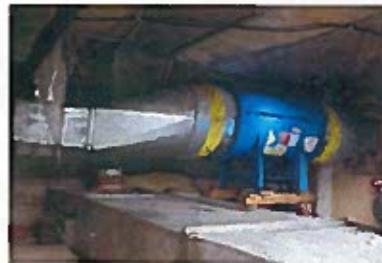
5) The building washrooms and holding cells located on both floors, on the south end of the building, are serviced by an existing large inline exhaust fan (Air-Care #129-Tubular) that is located in the Basement Mechanical Room. This exhaust fan itself is from original construction (1978), but it appears the fan motor has been replaced in recent years. This exhaust system appeared to be functional, however with the continuous discharge of exhaust air to the outside, forces the AHU#1 unit to continually bring in fresh air (MUA) to compensate for the pressure differential being created by the exhaust fan. The introduction of fresh air is desired, but there are much better and more energy efficient means to accomplish these provisions. When there is a negative pressure differential in the building, this creates drafts and envelope leakage, as make-up air (MUA) will try to infiltrate into the building through cracks around windows, doors, etc. This can cause comfort issues, and is not energy efficient. Typical office building design would be just the opposite, whereby the building actually has a slight positive pressurization to keep cold (or warm) outside air from infiltrating the building.

6) It was noted that the existing exhaust fan in the Police Department Washroom (lower basement) was not working at time of inspection. Considering sanitary exhaust is a code requirement, this E.F. should be replaced as soon as possible.

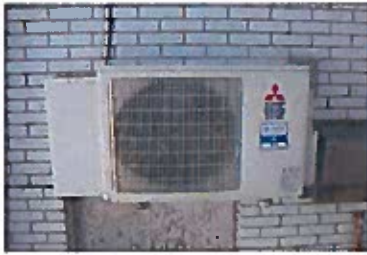
8) The Office building computer LAN room located in the basement is conditioned by a newer 1 Ton Ductless Split A/C system c/w -40F ultra-low ambient controls & crankcase heater. (Mitsubishi #PUY-A12NHA3 series c/w interior Fan coil and an exterior condenser unit). The serial number on the unit appears to indicate that it was manufactured in 2005, making it a 10 year old system. Typically these units have a 20 year life expectancy, considering that they work all year round. This system appeared to be in good operational condition.
